Autograph Precision Universal Testing Machine

Evaluation of Open-Hole CFRP

— Static Tensile Testing, Fracture Observation,
and Internal Structure Observation —

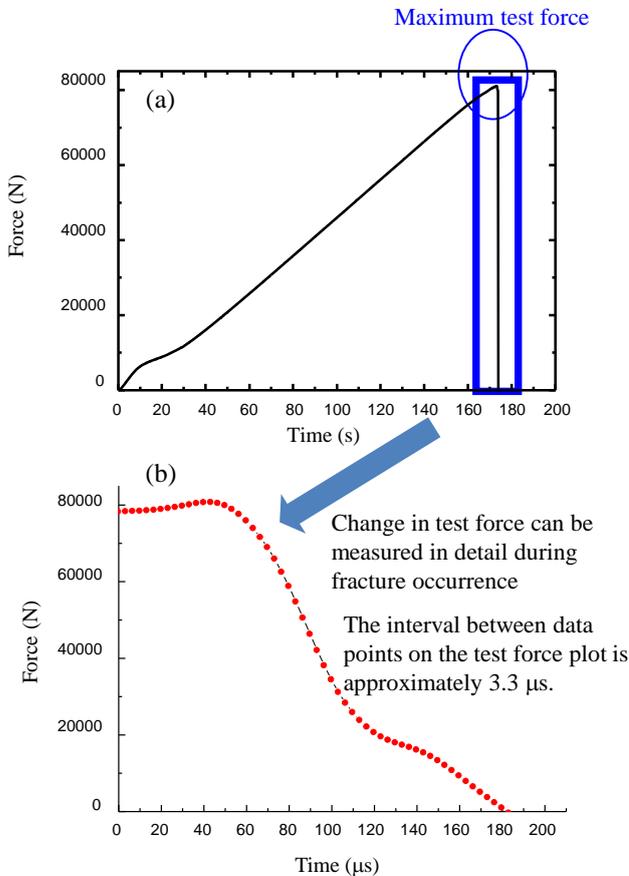
Fig. 2 (a) Test Force-Displacement Curve, and (b) Test Force-Time Curve (in Region of Maximum Test Force)

Fig. 2(a) can be interpreted to show the specimen fractured at the moment it reached the maximum test force, at which point the load on the specimen was suddenly released. This testing system can be used to perform high-speed sampling to measure in detail the change in test force in the region of maximum test force. The time interval between data points on the test force plot in Fig. 2(b) is 3.3 μs.

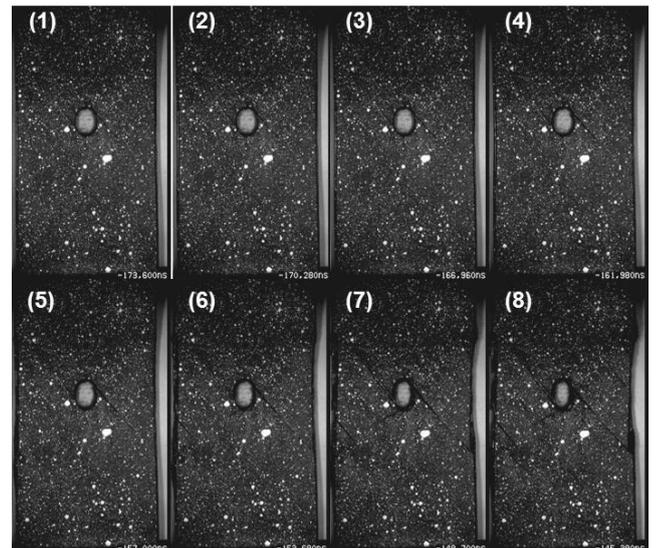
Fig. 3: Observations of OH-CFRP Fracture

Images (1) through (8) in Fig. 3 capture the behavior of the specimen during fracture around the circular hole. Image (1) shows the moment cracks occur in a surface +45° layer. In this image, the tensile load being applied is deforming the circular hole, where hole diameter in the direction of the load is approximately 1.4 times that perpendicular to the load. In image (2), the cracks that occurred around the circular hole are propagating along the surface +45° layer. In images (3) through (6), a substantial change can be observed in the external appearance of the specimen near the end of the crack propagating to the bottom right from the circular hole. This suggests not only the surface layer, but internal layers are also fracturing. Based on the images of the same area and the state of the internal layers that can be slightly observed from the edges of the circular hole in images (7) and (8), the internal fracture has quickly propagated in the 18 μs period between images (3) and (8).

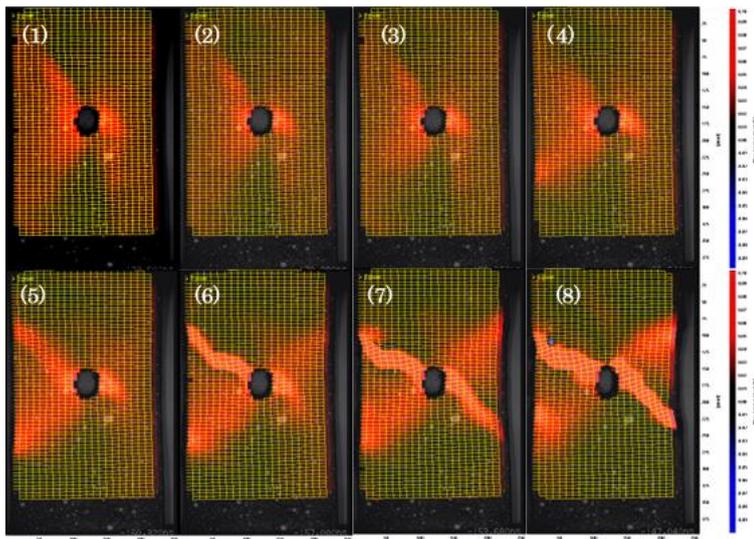
Fig. 4: Observation of OH-CFRP Fracture (DIC Analysis)

Images (1) through (8) of Fig. 4 show the results of performing Digital image correlation (DIC) analysis on the fracture observation images of Fig. 3. Black signifies areas of the surface layer of the specimen under little strain, and red signifies areas under substantial strain. Looking at images (1) through (4), we can see that strain around the circular hole is focused diagonally toward the top-left (-45°) and toward the bottom-left (+45°) from the circular hole. Images (5) through (8) show the focusing of strain diagonally toward the bottom-right (-45°) and toward the top-right (+45°) from the circular hole in areas where it was not obvious in images (1) through (4). This shows an event is occurring in the surface layer of the specimen that is similar to the process of fracture often seen during tensile testing of ductile metal materials, which is crack propagation in the direction of maximum shearing stress.

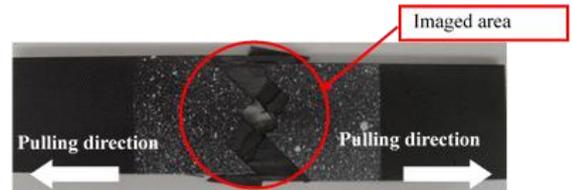
Fig. 7: Specimen After Static Tensile Testing (Specimen Used for CT Scan)

Next, internal observations were performed around the circular hole using a micro focus X-ray CT system to check the state of internal damage to the specimen. The SMX-100CT micro focus X-ray CT system (Fig. 5) is capable of capturing CT images at high magnification. The system rotates a specimen between an X-ray generator and an X-ray detector, uses a computer to calculate fluoroscopic images obtained from all 360° of rotation, then reconstructs a tomographic view of the specimen (Fig. 6). This system was used to perform a CT scan of the fracture area of the OH-CFRP after the static tensile testing and fracture observation performed as described in the previous section, so that the cracks that occurred inside can be observed.

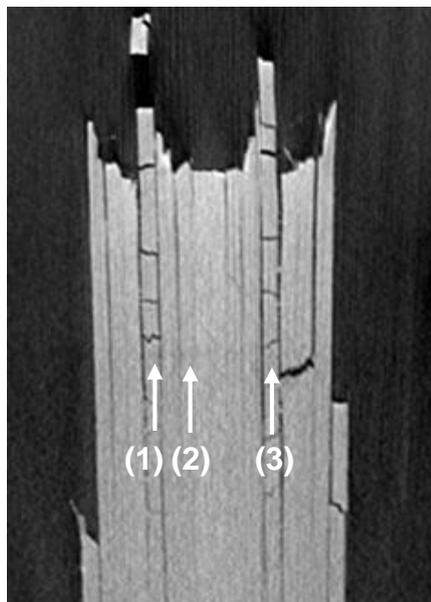
Fig. 9: CT Cross-Sectional Images of the Fracture Area

Cross-sectional images of the specimen are shown as a 3D image in the 16 layers shown in Fig. 9, we can see that most cracks in the matrix occur in the $+45^\circ$ layer inside the specimen, indicated by the number (1) and (3). (shown in Fig. 10 (a) and Fig. 10 (b), respectively). In this layer, the carbon fibers are all aligned together in a $+45^\circ$ orientation, and the multiple matrix cracks occurring in this layer are probably due to the shearing force caused in this layer by tensile loading, together with deformation of adjacent layers in the direction of the loading. For comparison, a 3D image of the -45° layer inside the specimen (Fig. 9 (2)) is shown in Fig. 10 (b). As is clear from the image, the matrix cracks that occurred in the $+45^\circ$ layer have not occurred in the -45° layer. This difference in fracture state has probably arisen due to different shearing forces and load directions occurring in each layer. Such detailed observation of fracture surfaces associated with multiple matrix cracks was difficult by conventional methods, since to observe fracture surfaces the specimen was processed such as by cutting and embedding in resin, which changed the characteristics of the specimen. However, by using the high-resolution X-ray CT system as described in this article, there is little X-ray absorption difference between air and specimen, and it is possible to observe the state of complex internal damage, even for OH-CFRP in which microscopic damage is normally difficult to observe by X-ray.
